# Hyundai Avante, 2018

VIN: KMHD641DBJU523198      Report ID: 251d9e7f928774e7112631528bca2e3c

Report Date: 2025-02-20

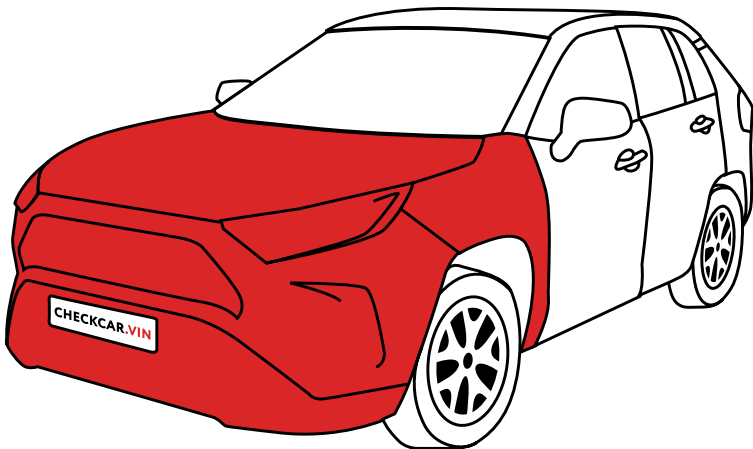
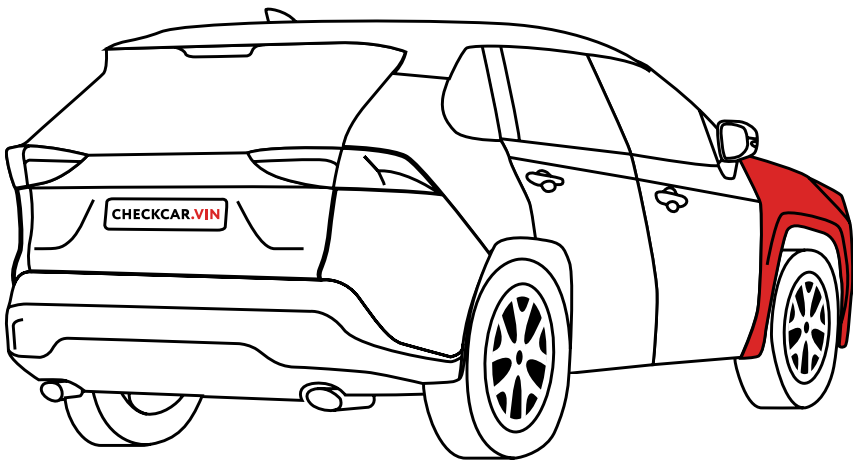
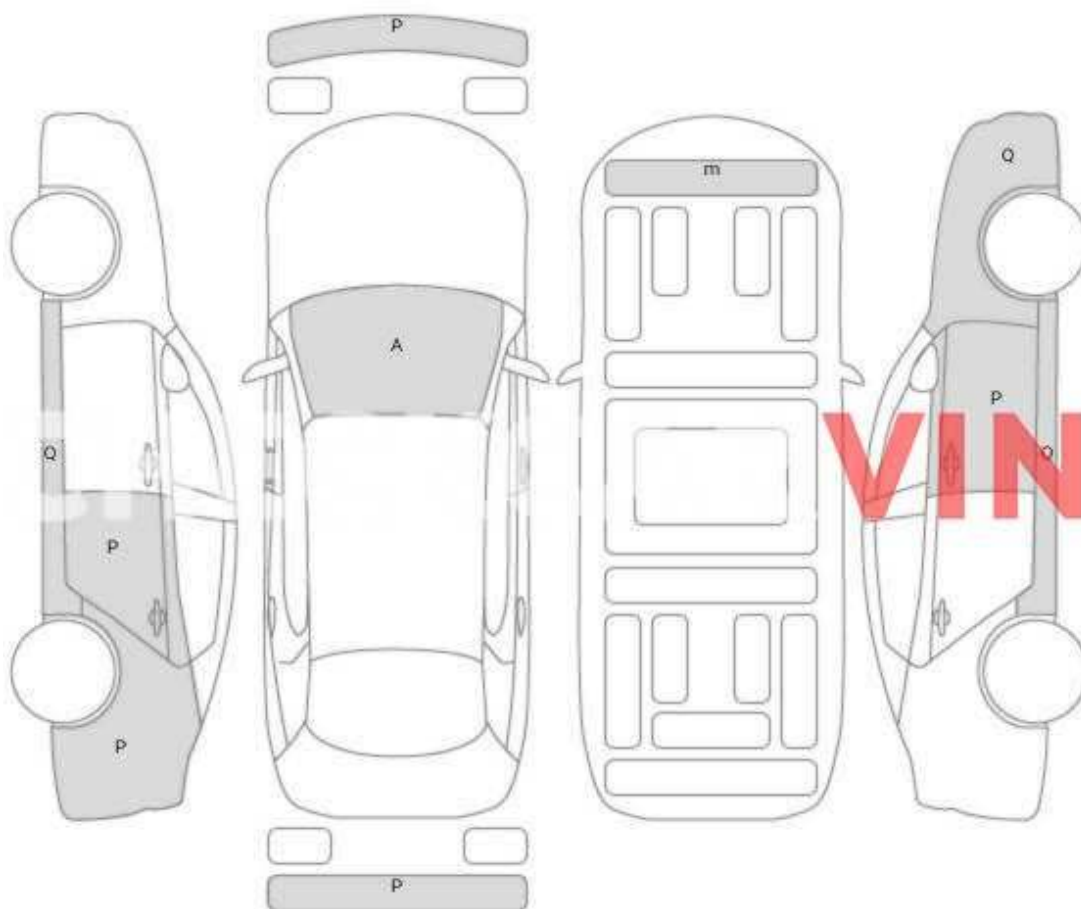
2024-04-30

⚙ Damage 1	Front Bumper	Stamps
⚙ Damage 2	Radiator Grille	Detach
